**REPAIRS WORKS OF DAMAGED CONCRETE STRUCTURES AT SEA
RASCO HARBOUR BERTH 3A & 3B CAISSONS REHABILITATION - ABOVE WATER AREA**

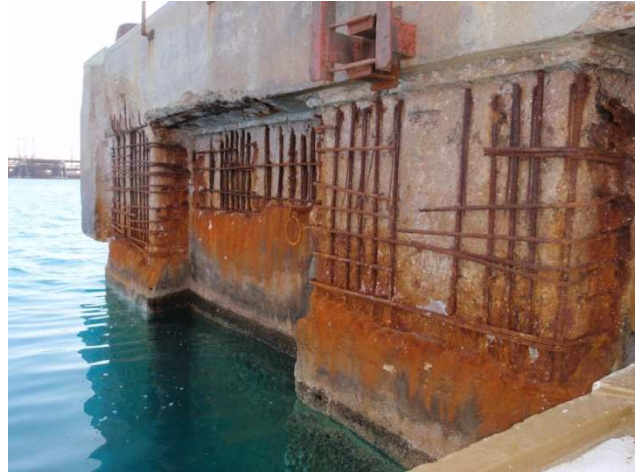
Photos no. 1 and 2 evidence the conditions of the concrete structures and rebars.
