SINMAST DIVERS AT TARBELA

JOB RECORD
N° 5

TARBELA DAM SITE – PAKISTAN

THE TARBELA DAM

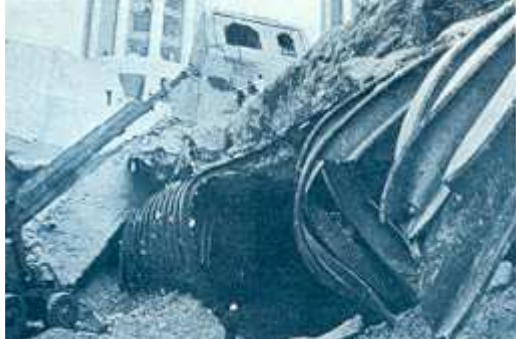
Tunnel 2. The collapsed section during removal of damaged ribs. (Courtesy of Water Power and Construction -June-July 1975)

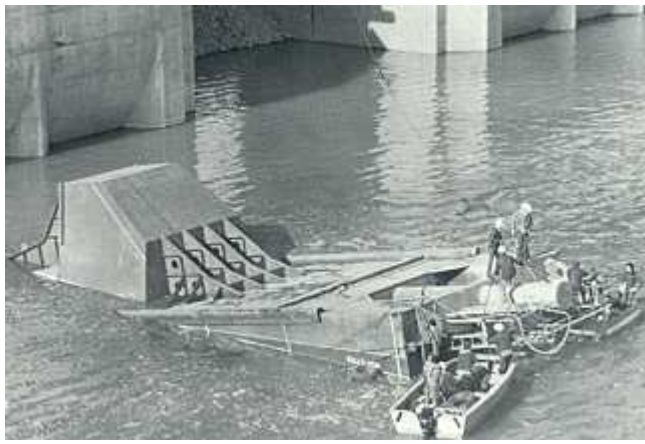
Intake tunnel 1. Positioning of the barge gate.

Both the gate and the concrete structure were in poor condition hindering dewatering. The divers faced the turbulent water in the downstream area of the gate passage to fill the enormous caverns in the invert and in the piers, with sand bags and other suitable material, until the cofferdam was completely drained. Repair work was then completed on two gates of tunnel 2 but only in one gate in tunnel 1. The repair of the fourth gate raised serious difficulties. It had been badly damaged by the earlier uncontrolled passage of water. A decision was taken to remove this gate and replace it. In order to carry out the removal and replacement operation it was necessary to seal the upstream end of the gate passage, so that the repair work inside the tunnel could continue uninterrupted, whilst the inflowing water was diverted in the already repaired irrigation tunnels 3 and 4.

A unique barge gate was designed by Messrs. Interconsult (Milano, Italy) and constructed in the site workshop for this purpose.

The caisson, operated by flooding of buoyancy tanks, was eventually positioned with the help of *Sinmast Divers*, who played an important role both below and above the surface, A few days after the replacement of gate 1 of tunnel 1, the tunnel was returned to full operating capacity and the barge gate was eventually removed.

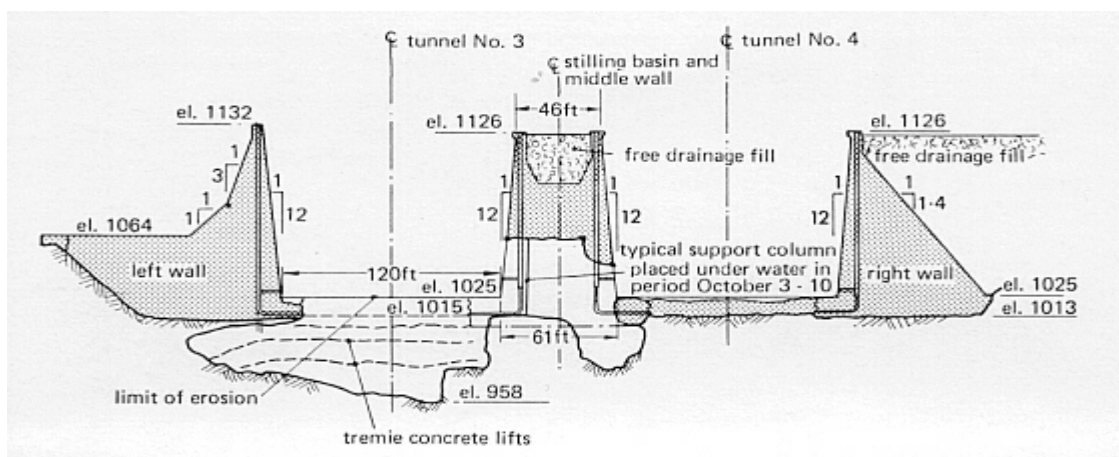
The outlet gates of the tunnels were closed and Sinmast Divers called in to carry out an inspection of both stilling basins. Again working with zero visibility they were soon able to report that large areas of the floor slabs of stilling basin 3 had been broken up and swept away, and that a huge cavern had developed below the slabs. Facing the complete darkness, the unknown shape of the remaining structure and the huge debris dangerously leaning on the working area, the divers were able, after few days, to plot the outline of this cavern.

Stilling basins. Tunnels 3 and 4. Typical section showing the limits of erosion. (Courtesy of Water Power and Dam Construction-January 1976)

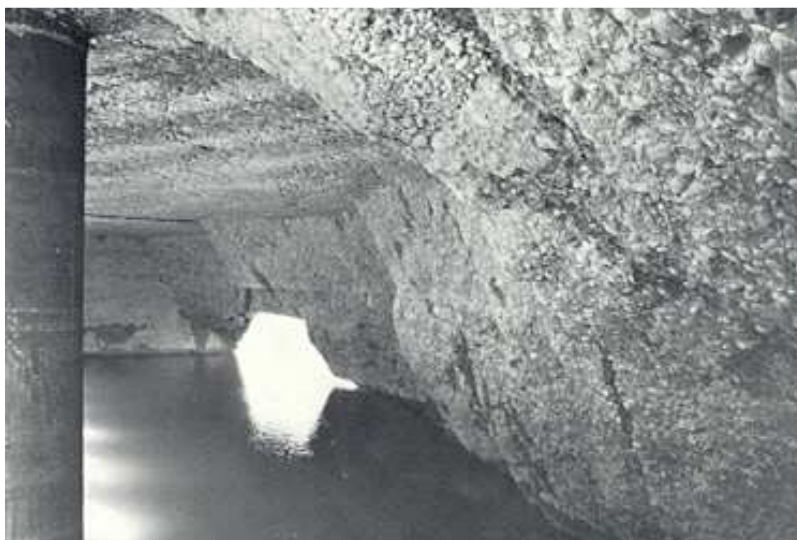
Continued inspections revealed that both side walls of stilling basin 3 had been seriously undermined. To ascertain the extent of the damage, the divers were forced to dive as much as 45 m. and to traverse 15 or 18 m. below the overhanging walls, to plot the outline of the eroded foundation.

Stilling basins. Tunnels 3 and 4. eroded cavern below the middle wall.

The climax was reached when they eventually located a passage of erosion through the dividing wall between the stilling basins, and where able to swim from one basin to the next, thus proving that the dividing wall was spanning like a bridge over the missing foundation, for a total length of more than 75 m., and that a huge portion of the concrete monoliths had collapsed on the bottom of the cavern. Once the general picture of the erosion had been established for planning the repairs, Sinmast Divers were utilized to carry out an accurate underwater survey.

From the information provided by our team, it was realized that only the fortuitous keying together of adjacent wall monoliths was preventing a total collapse of the walls overlying the deepest erosion. It quickly became apparent that the stilling basins could not be safely dewatered without first filling the eroded area with some structurally suitable material. A tremie concrete solution was eventually selected.

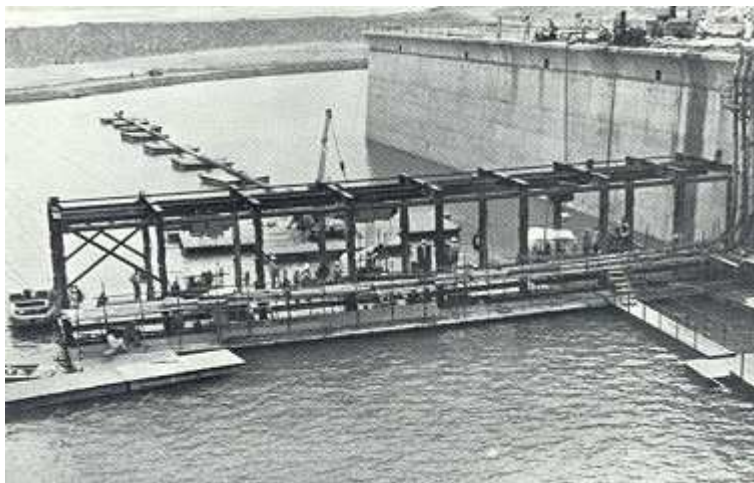
Stilling basins. Tunnel 3. Tremie concrete pontoon.

What was to prove to be the world's largest ever tremie concrete operation of cu.m. 43.000 commenced on 15 September and was completed by 15 October 1975. An efficient and accurate underwater monitoring system of the whole operation was provided by Sinmast on a round-the-clock basis. Sinmast Divers were used both to assist in the work of fixing and operating tremie tubes and also to provide factual observations on the actual placement of the concrete.

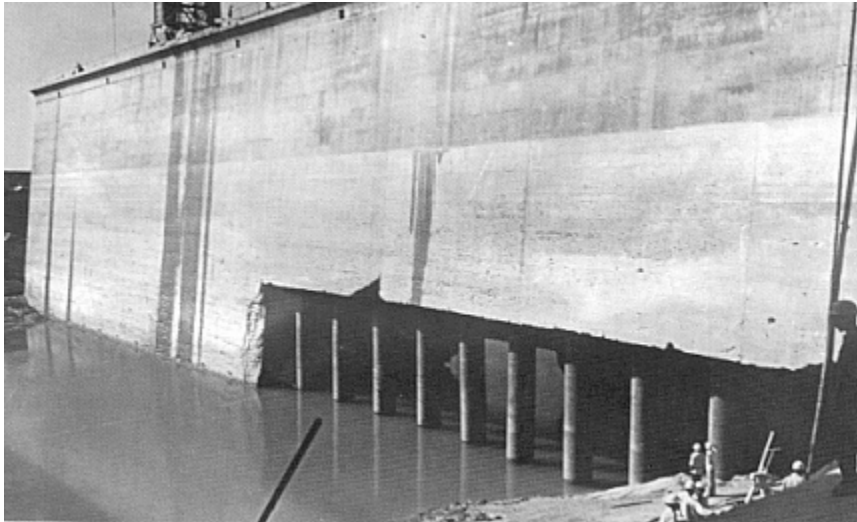
Stilling basins. Tunnel 3. The 1.500 m/m dia. steel props installed by the divers to support the undetermined middle wall

This provided the supervisor with the fullest knowledge of the pour progress, to enable him to take such action as might be necessary. With the completion of the tremie operation, the next step was to underpin the dividing wall so that the basins could be safely dewatered. Nine prefabricated steel piles, each 1.5 m. dia. and about 12 m. long, were suspended by Sinmast Divers under the wall, directly beneath a series of existing 200 mm. dia. drain holes. The tubes were then filled with tremie concrete dropped through the drain holders: rubber skirts were fitted at the top of the tubes to prevent leakage of grout.

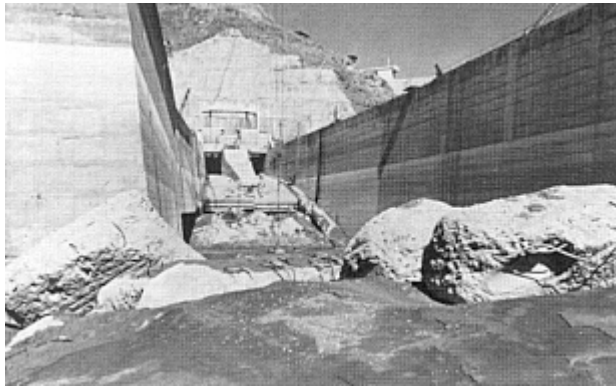
With the satisfactory completion of this operation, it was possible to, very cautiously, dewater the stilling basins. The damage was massive. Much work was necessary to restore the structures. However, the accurate information supplied by the Sinmast Divers' survey team was already available for planning to proceed. The repairs could now be completed with maximum speed.

Stilling basins. Tunnel 3. After dewatering on nov.75

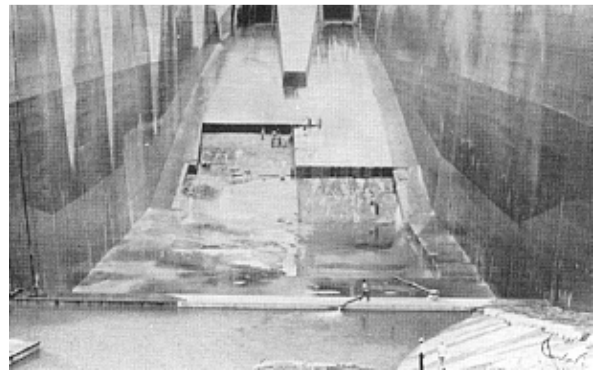
Stilling basins. Tunnel 3. After dewatering on summer 76

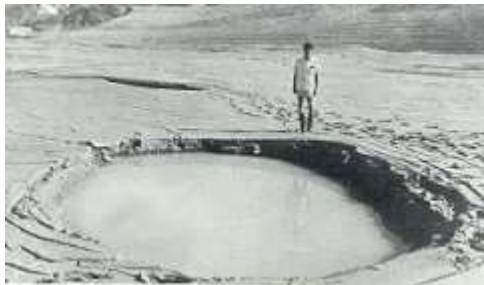
Impervious blanket. Typical sinkhole. (Oct.74)

Sinkholes consist of holes with near vertical sides varying in diameter from 0.6 to 10.0 meters and up to 3.5 m. deep, which have the appearance of having been punched into the protective blanket.

As the water receded, more sinkholes came into view, until a total of more than 400 were logged. These sinkholes were repaired by conventional methods, using trucked-in normal fill.

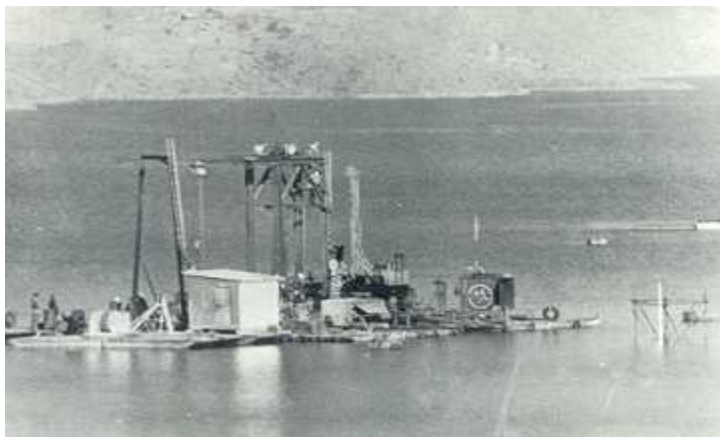
Right bank intake area. Pontoon for the drilling and grouting of the air vent gallery to control water seepages in tunnel 2.
